Inspection Report

LOCATED AT:
1234 Aloha Street
Honolulu, Hawaii 96814

INSPECTED ON:
Monday, January 1, 2018

Inspector, Jay Cadavona
Home Inspections Oahu LLC (808) 220-8686

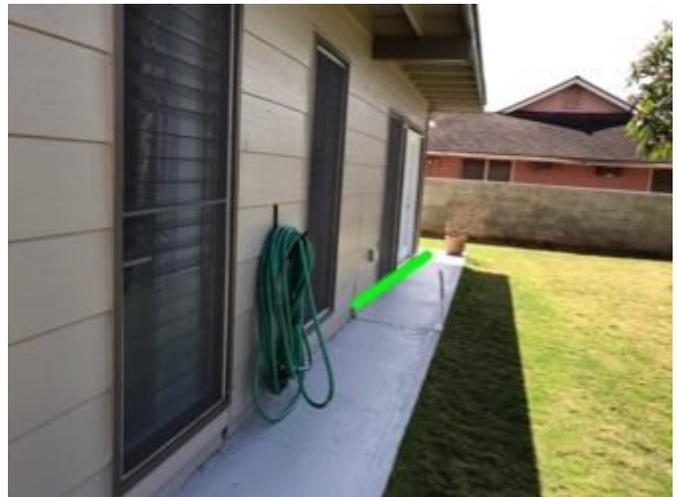
rear of home

UPG The edge of the siding at the rear den of the home is close to the ground. For proper drainage and drying, we recommend that the bottom edge of the siding be 2" above concrete, and 6" from the earth.

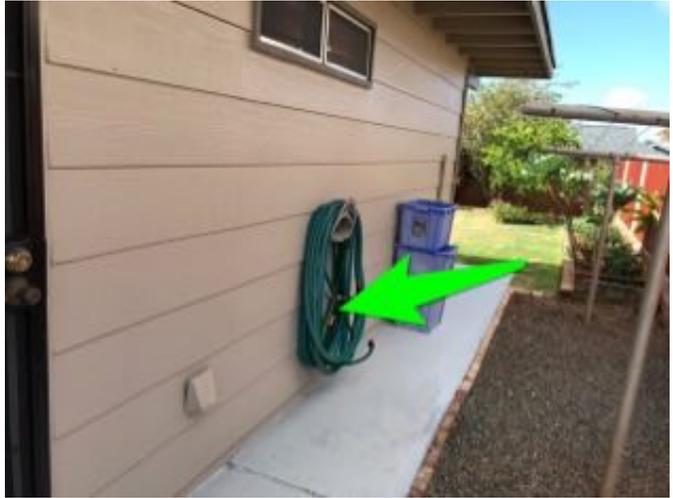
west side of home

UPG Gaps in the hardboard siding were observed at one or more of the pipe and/or vent penetrations. We recommend all such gaps be sealed or plugged in the course of routine property maintenance.

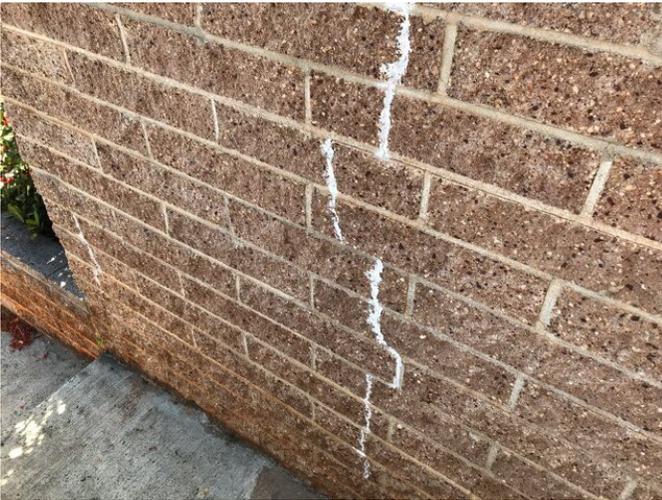
example

UPG The masonry walls are cracked in several locations. It has the appearance of reinforcing steel corrosion, causing the CMU to crack. For a better appearance and prevent and help prevent further deterioration, we recommend proper spall repair practices.

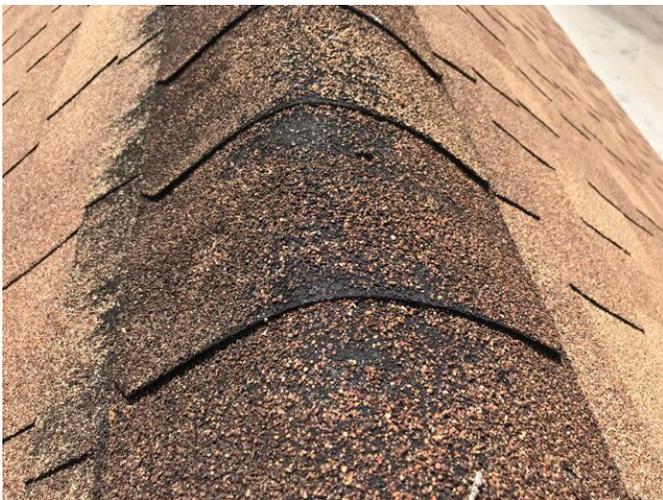
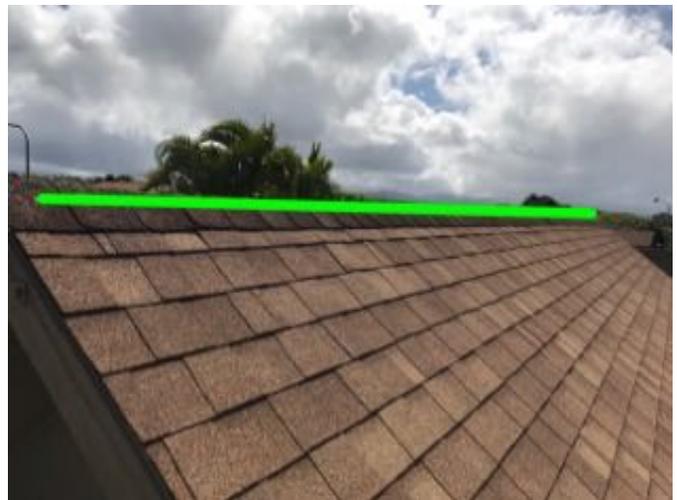
example

UPG The ridge cap is showing signs wear and loss of surface granuals. The roof appears to be water tight at the moment. To prevent possible water intrusion, it is recommended to replace the ridge caps in the near future.

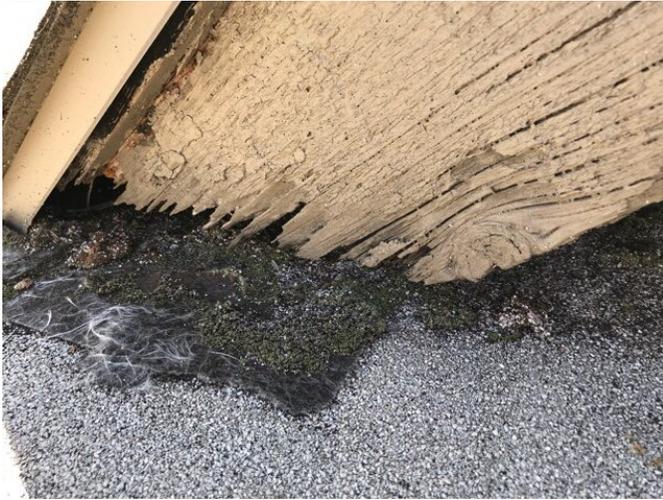
example

The rake edge is deteriorated and has signs of dry rot. Repair or replacement is recommend.

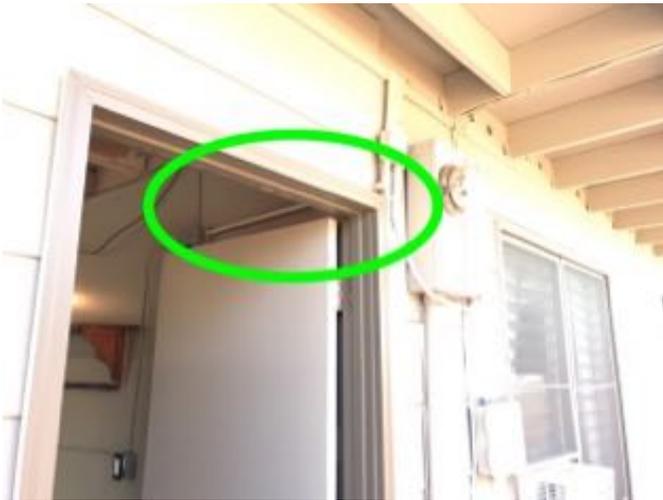
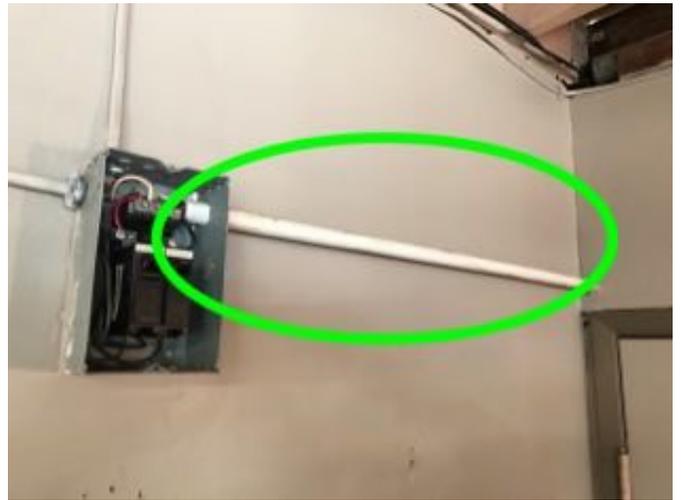
Irrigation type of PVC has been used to feed the garage junction box. This is not an approved practice. It is recommend to have the advice and services of a qualified licensed electrical contractor correct the issue.

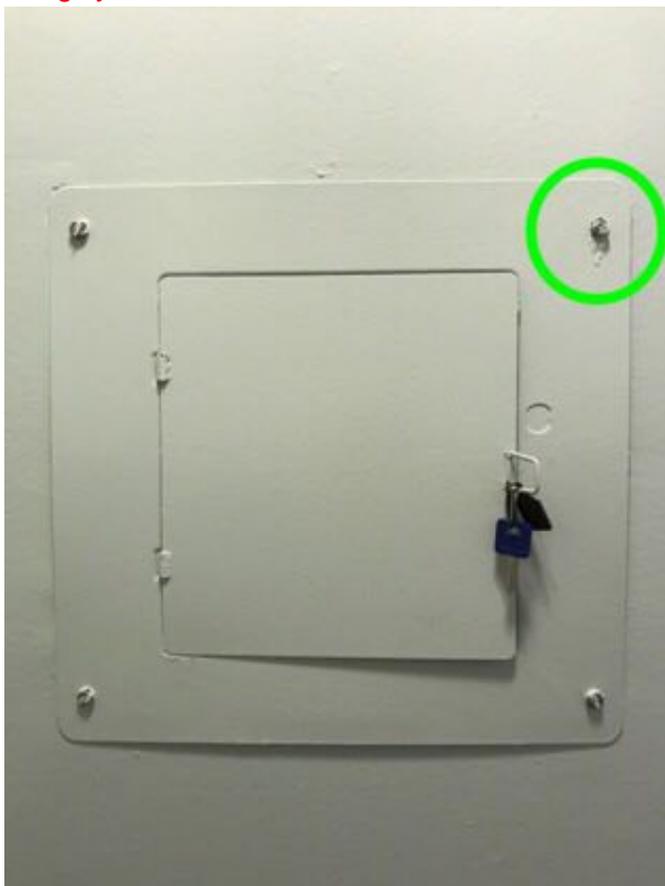
WARN The subpanel cover is loose because the upper right screw is too short. Installation of a longer screw is highly recommended.

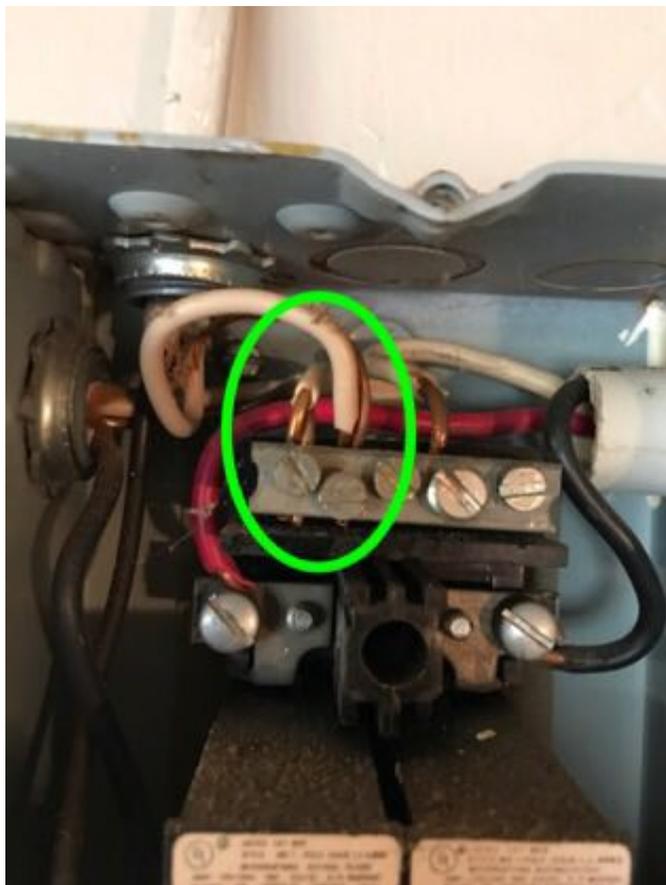
garage

WARN Multiple wires are installed on individual terminals. This 'double lugging' is not permitted because a positive connection for all wires are not assured. We recommend reconfiguration of the circuitry so that each wire connects to only one terminal. It is recommend to have the advice and services of a licensed electrical contractor correct the issue.

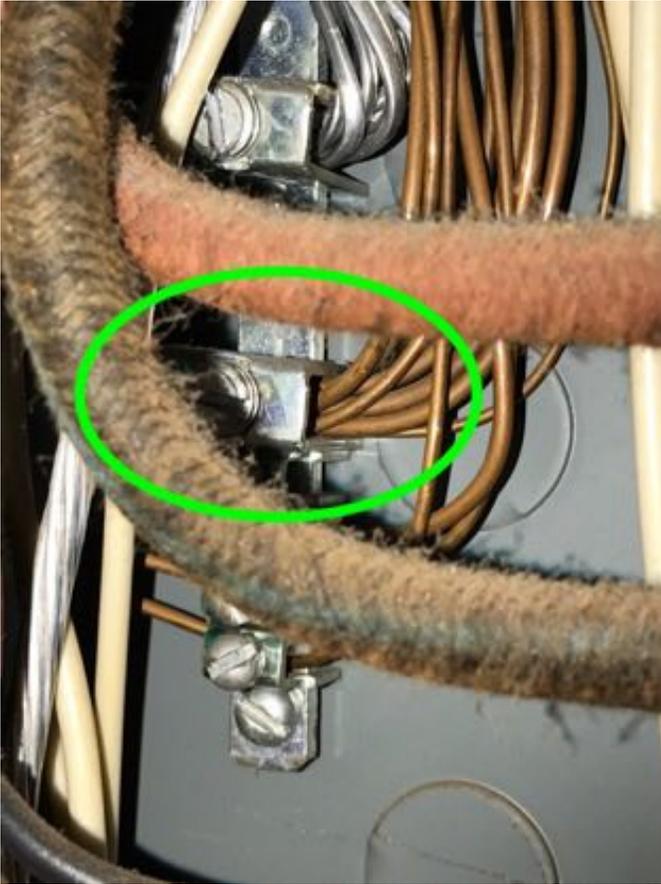
multiple wires under one set screw

The grounding method for the subpanel is non-compliant to today's standards. We recommend the advice and services of a licensed electrical contractor correct the issue.

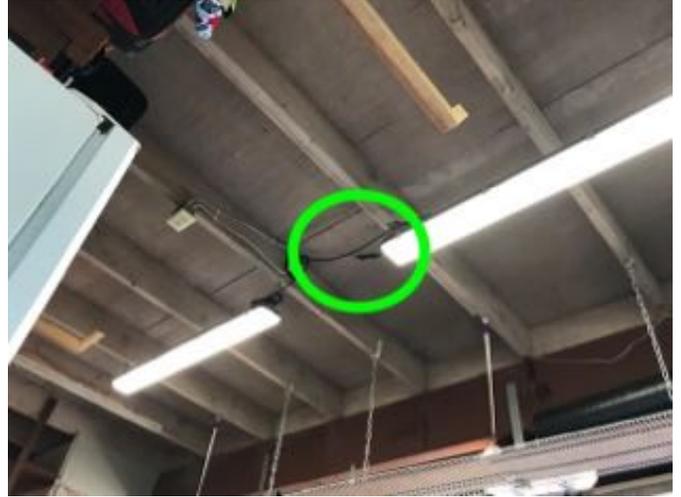
WARN Running splices, which are improper connections outside of a junction box, were observed. We recommend connections be joined with approved connectors inside a junction box to prevent accidental contact or mechanical damage. It is recommended to have the advice and services of a qualified licensed electrical contractor correct the issue.

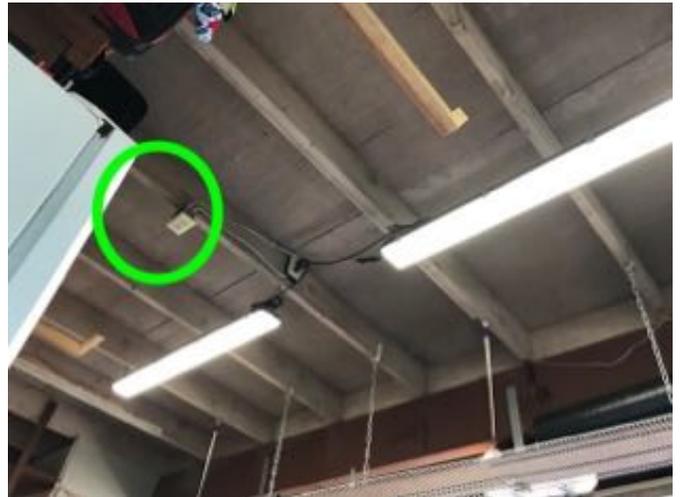
WARN The receptacle in this room does not have ground, posing a potential electrical hazard. We recommend the advice and services of a licensed electrical contractor correct the issue.

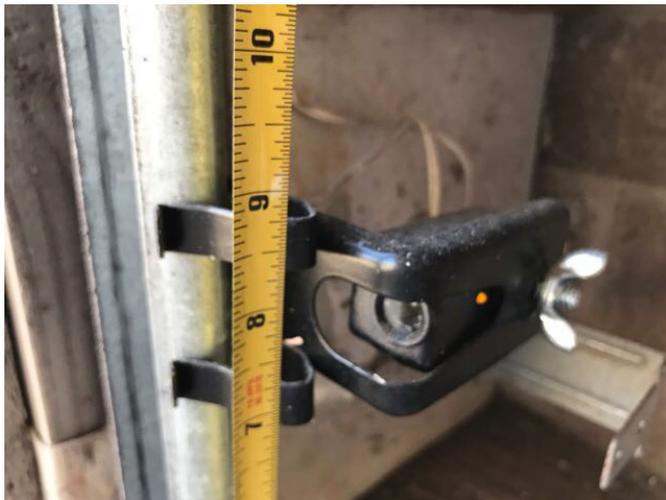
UPG The garage door opener operated properly when we raised and lowered the door, including the auto-reverse mechanism. However, the motion sensors were mounted too high on the frame, which could pose a safety hazard. We recommend reinstalling the sensors so they are no higher than 6 inches.

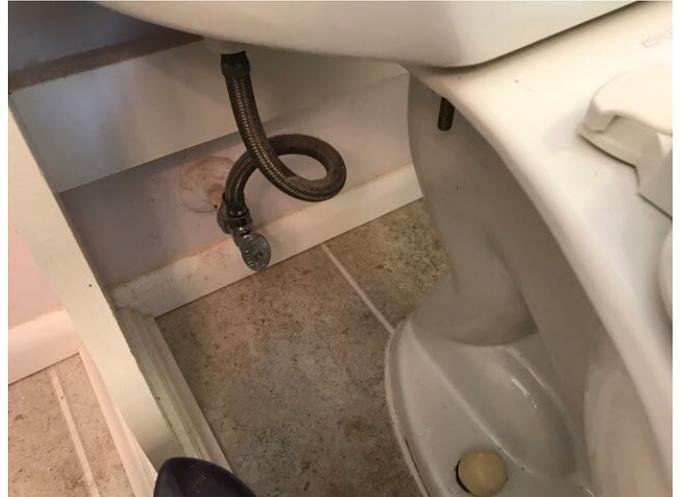
UPG The toilet is running continuously. This condition is extremely wasteful of water. We recommend that the fill valve be adjusted or replaced by a qualified licensed plumber.

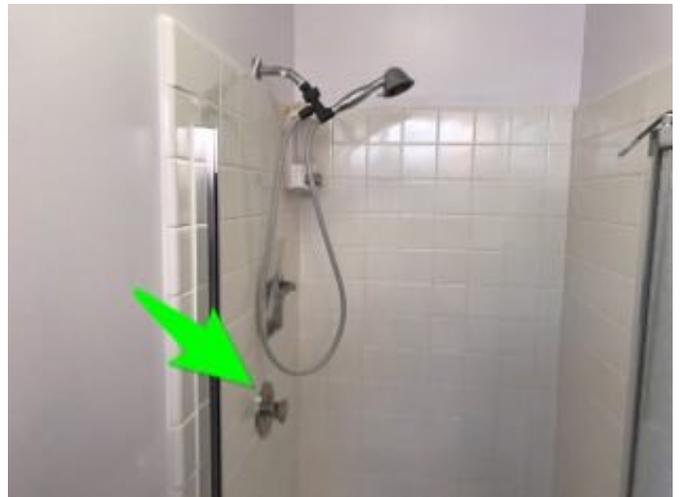
UPG There is no caulking around the fixture(s). To prevent possible water intrusion, we recommend installation of silicone caulk around the fixture.

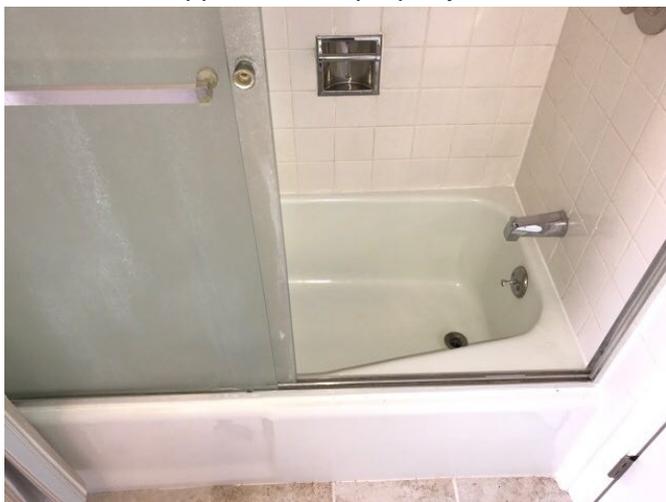
UPG The drain stop is not operational. We recommend it be repaired or replaced.

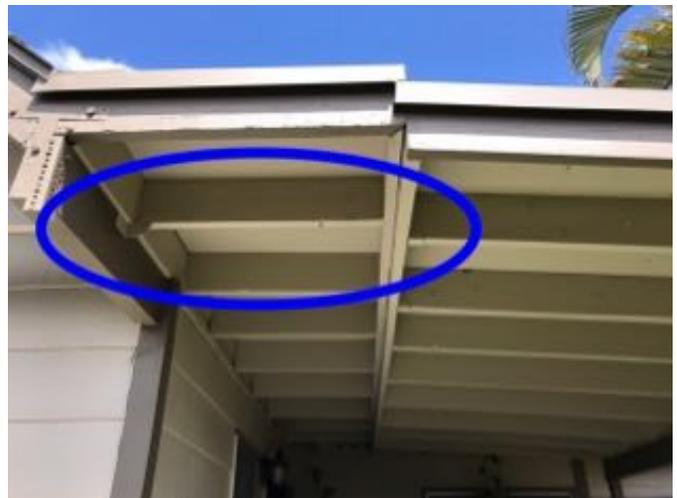
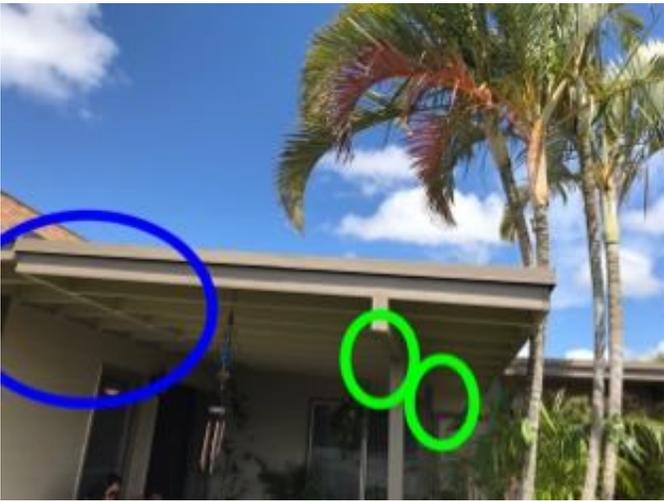
WARN The lanai cover does not appear to be properly constructed. The beam is does not have a post cap on both sides (green circle), the roof rafters are spliced (blue circle), and do not span the entire length from the homes framing members to beam. It is recommend to have the advice and services of a qualified licensed general contractor correct this issue.
